bulletin

NUMBER 204 – SUMMER 2014

Response to Disaster: USAID and ARCE Assist in Repairs

Preservation & Interpretation of the Palace of Amenhotep III at Malqata in Western Thebes

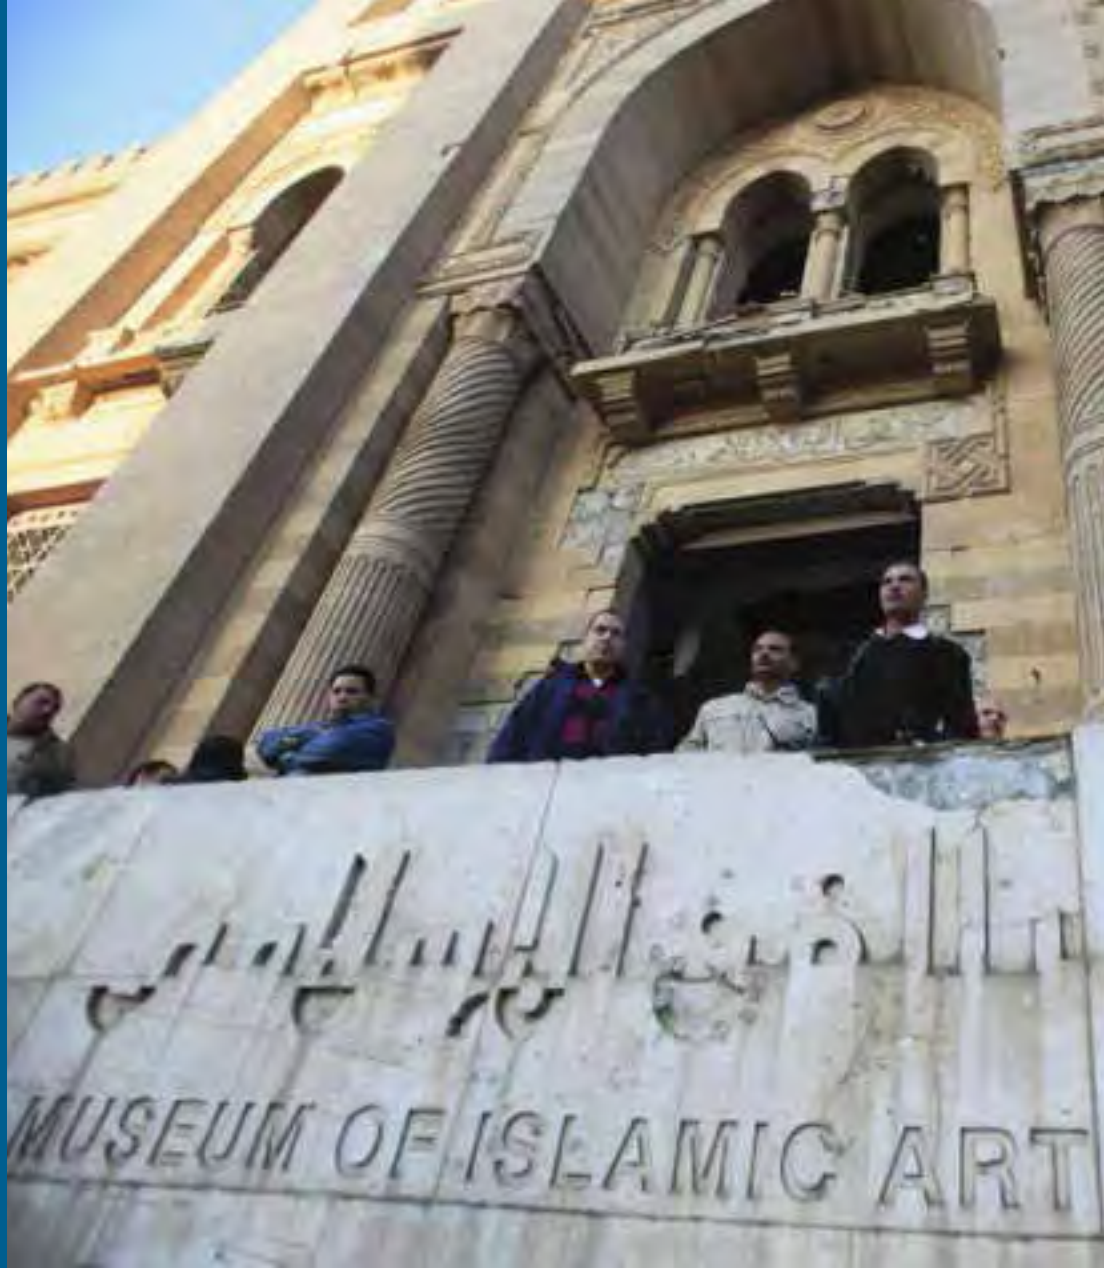
Fig. 1—Entrance of the Museum of Islamic Art after the bombing. Photo courtesy of the MoA

Because the explosion occurred very early on a Friday morning the number of fatalities and casualties were mercifully low; however, extensive collateral damage was done to a building across the street from the Cairo Security Directorate housing one of the world’s most significant collections of Islamic art and manuscripts. This building, constructed in what is known as the Neo-Mamlouk Style, was completed and inaugurated by Khedive Abbas II Hilmi in 1904. Today, the ground floor is occupied by the Museum of Islamic Art, managed by the Ministry of Antiquities (MoA); and the upper floors house the Manuscript Library and Manuscript Museum collection of the National Library and Archives of Egypt (Dar el-Kotob, Bab el-Khalq), under the

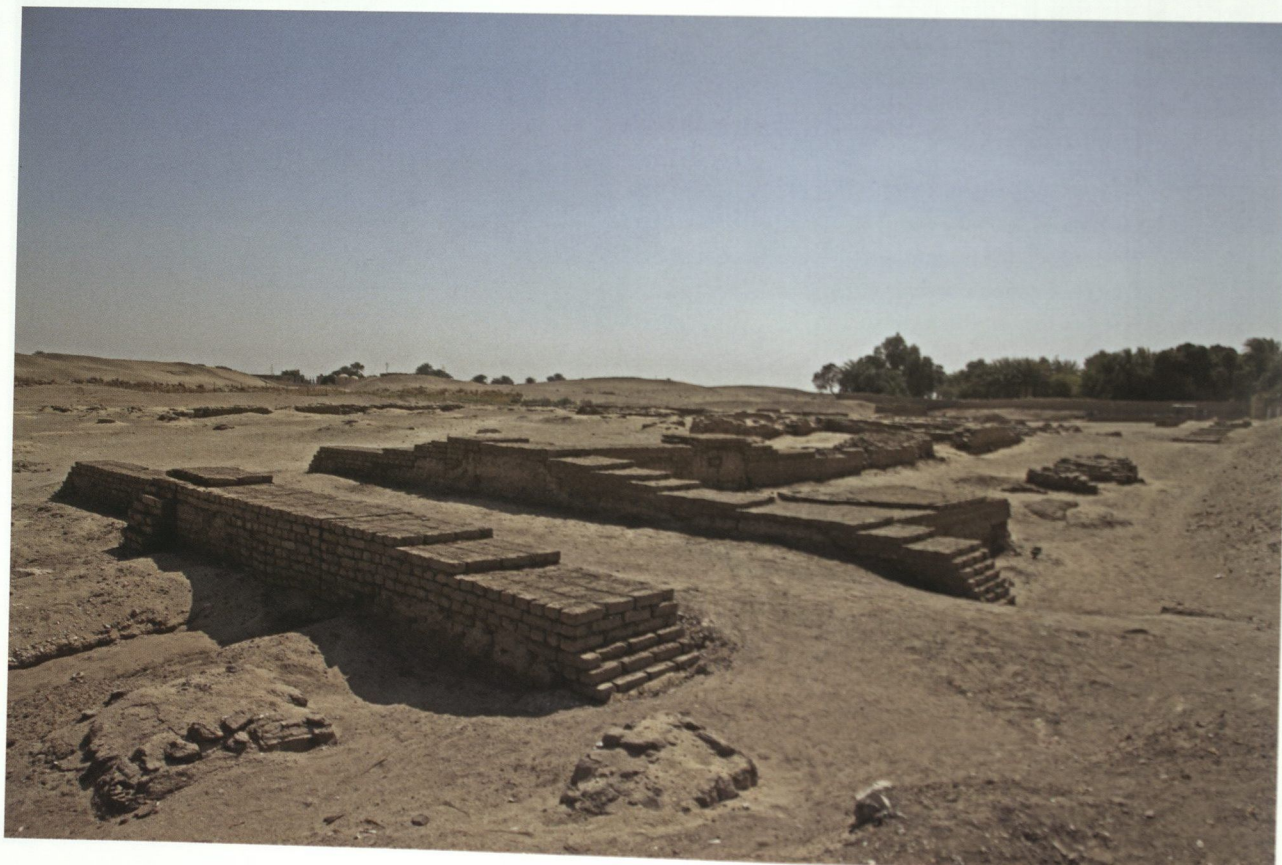
Fig. 1—Entrance gate of the King's Palace looking due south. Modern brick protects the highest preserved section of wall and is stepped down to indicate that the original wall continued.

As a result of this season's work, the gateway is clearly defined along with the adjoining enclosure walls (Fig. 1). In the main court the walls defining the west side, one of the north walls, and two sections of wall on the south side of the court were conserved (Fig. 2). In the main throne room, the throne platform was delineated with new mud bricks (Fig. 3). The southeast perimeter walls have also been more clearly defined (Fig. 4). In each case the original bonding patterns and masonry techniques were reproduced as accurately as possible. During conservation of the palace walls, areas where the original mud wall plaster is still preserved were stabilized and separating plaster was reattached to the walls (Figs. 5, 6).

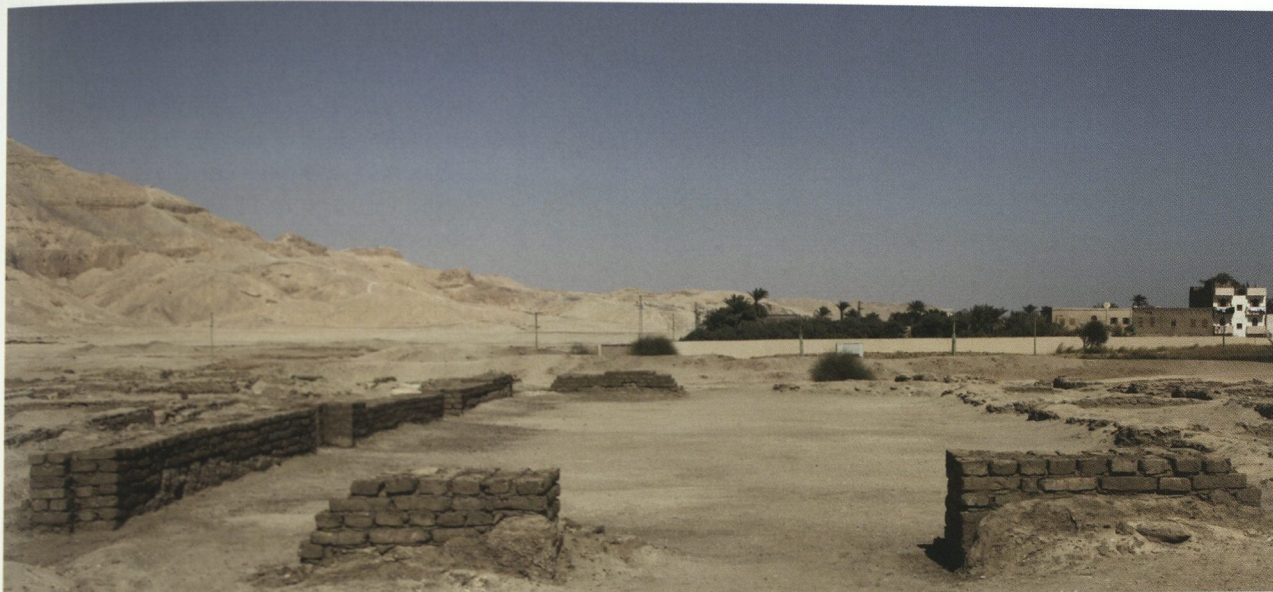
Fig. 2—Main court of the King's Palace looking local north. Finished edges of the two walls in the foreground indicate the preserved entrance into the main throne room. Stepped left edge of the center left wall indicates that the wall originally continued, but is no longer preserved.

new mud brick (Fig. 2). Likewise, if there was clear evidence of an alteration to a wall, such as the later closing of a previous opening, that was clearly shown in the new brick work (Fig. 11).

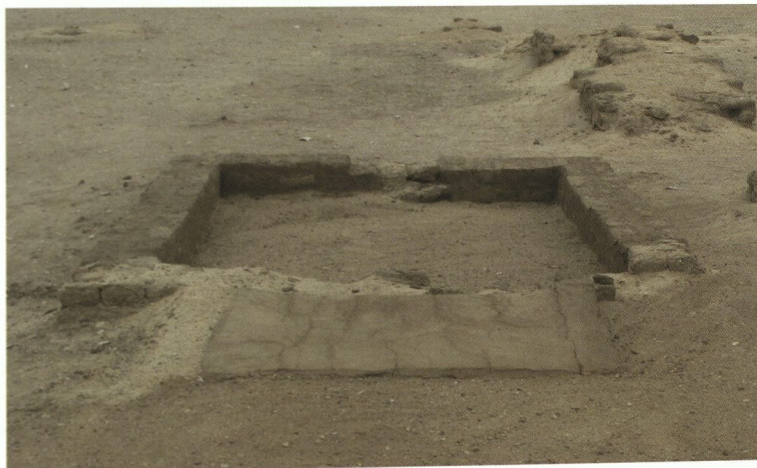
Fig. 3—Throne platform in the main throne room of the King's Palace.

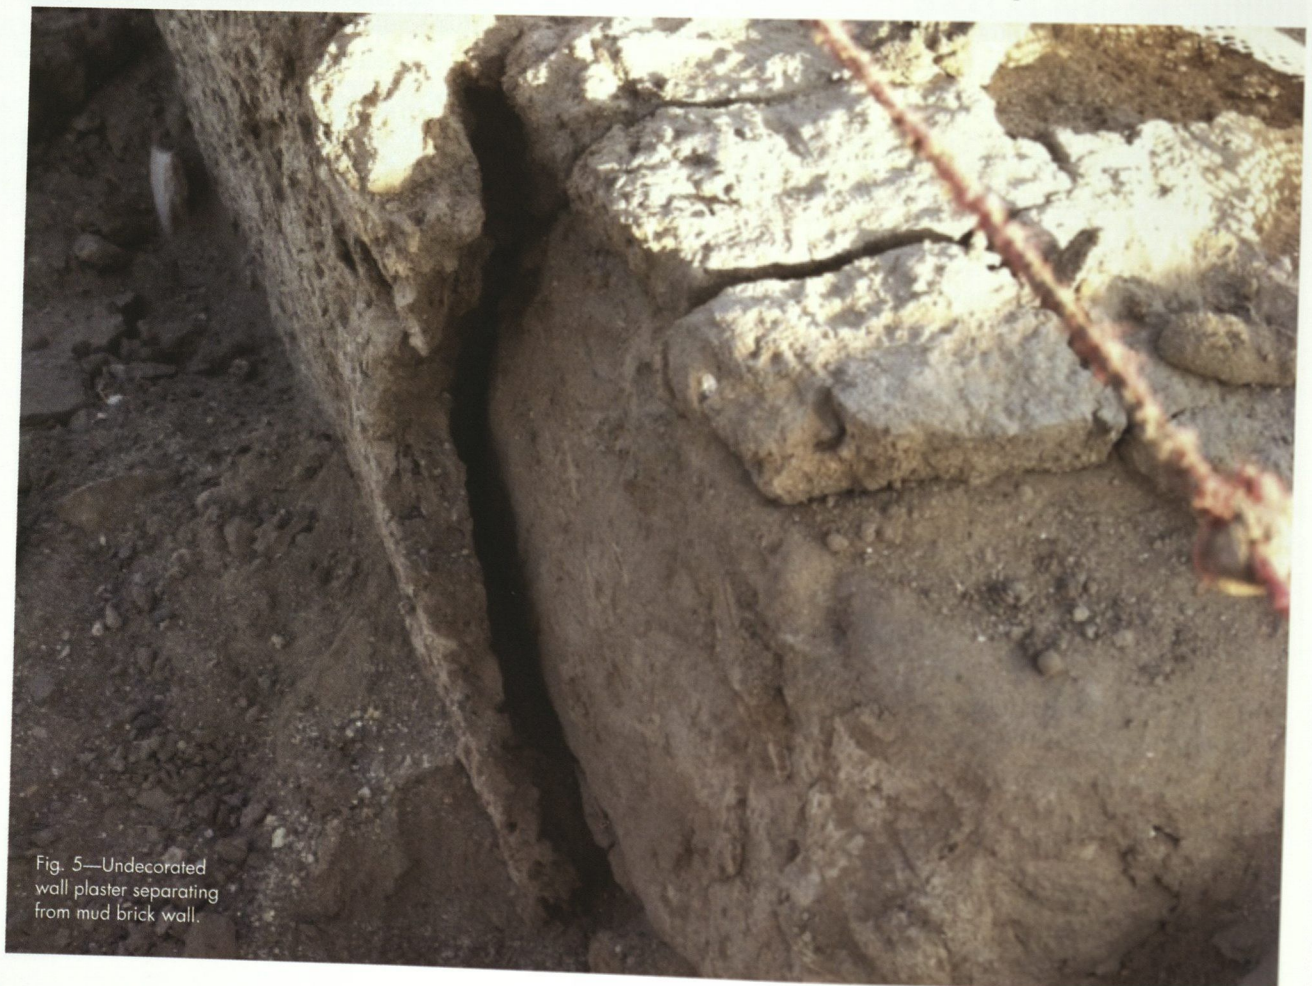
Fig. 5—Undecorated wall plaster separating from mud brick wall.

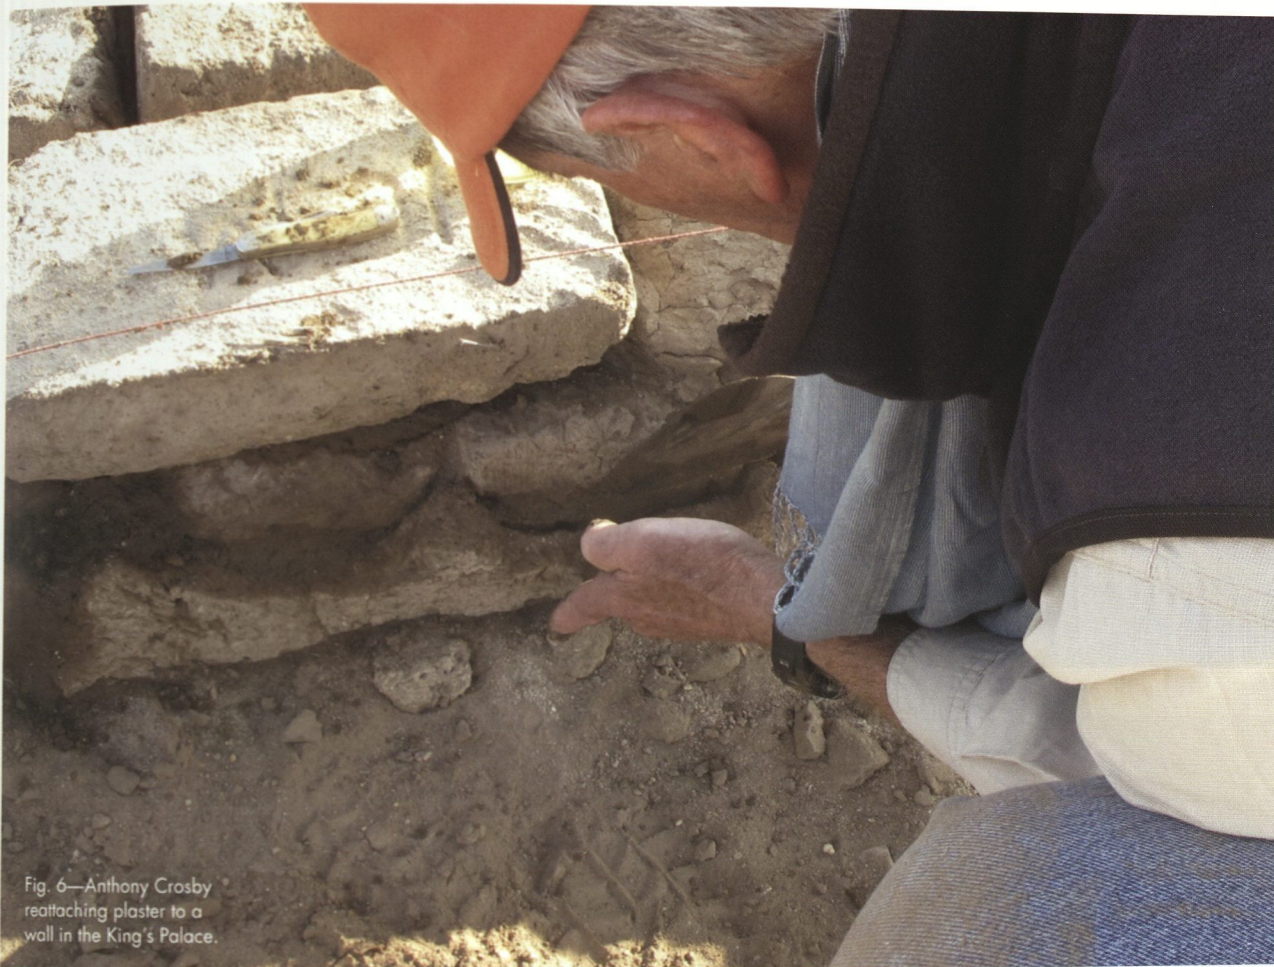
Fig. 6—Anthony Crosby reattaching plaster to a wall in the King's Palace.

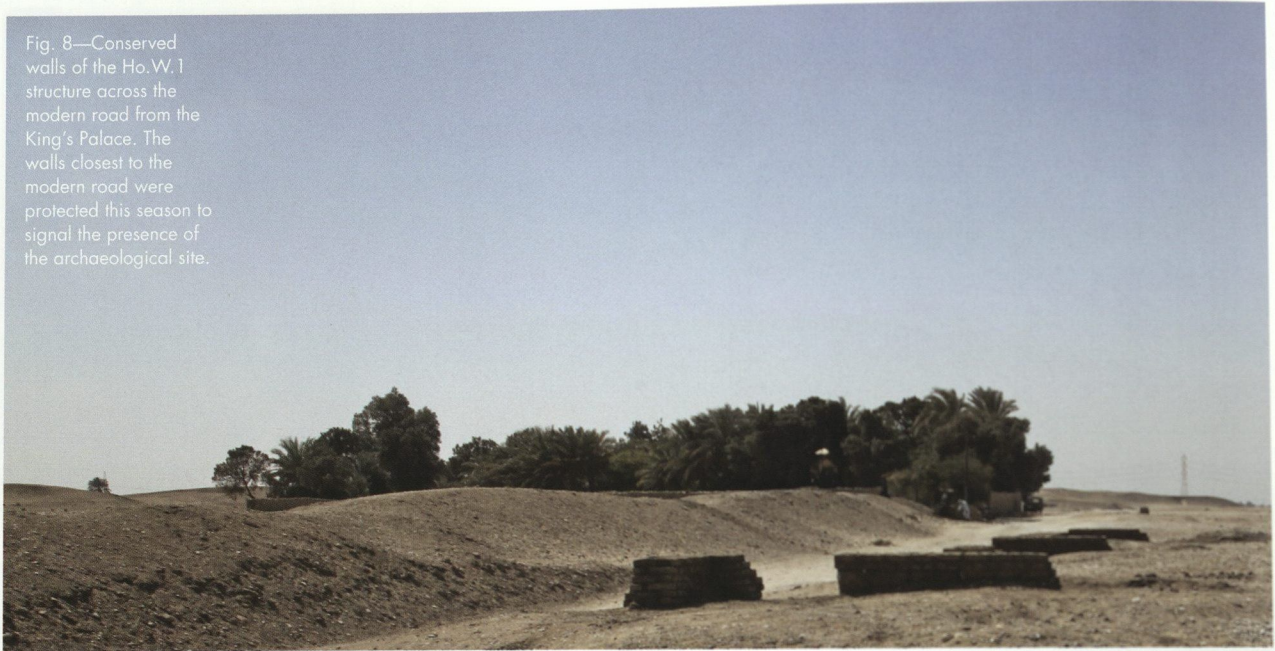
Fig. 8—Conserved walls of the Ho.W. 1 structure across the modern road from the King's Palace. The walls closest to the modern road were protected this season to signal the presence of the archaeological site.

In Ho. W. 1, four walls were conserved in an area where vehicular traffic had begun destroying the structure (Fig. 7). In this case the walls were capped and stabilized and several additional courses were added to clearly identify this area as an important component of the overall palace complex (Fig. 8).

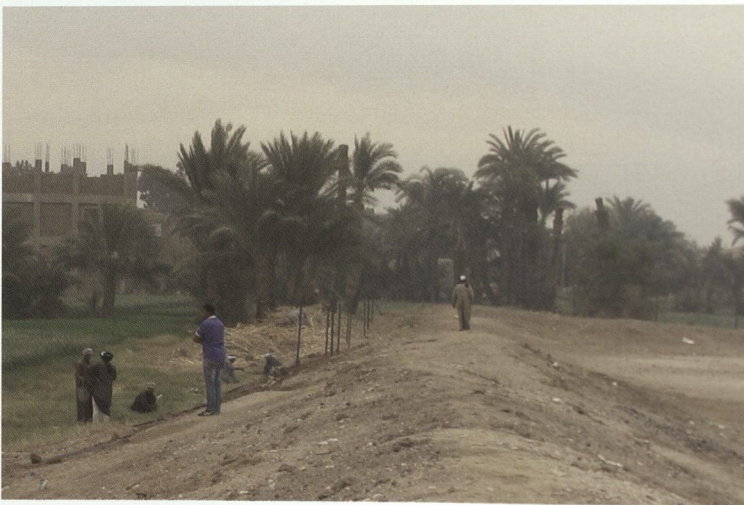
Fig. 9—Metal fencing being strung along the northern side of the King's Palace on a line determined by the MSA.

expeditions will be left intact as they are now an historical feature of the site. They also provide a useful berm to protect the Palace from wind and traffic, and they are less obtrusive than any newly built structure would be. For additional security, steel fencing has been installed around the perimeter of the Palace at the request and under the direction of the MSA (Fig. 9). We also added fencing to the adjacent structure, Ho. W. 1 to prevent vehicular traffic from taking shortcuts through the ancient building (Fig. 10).

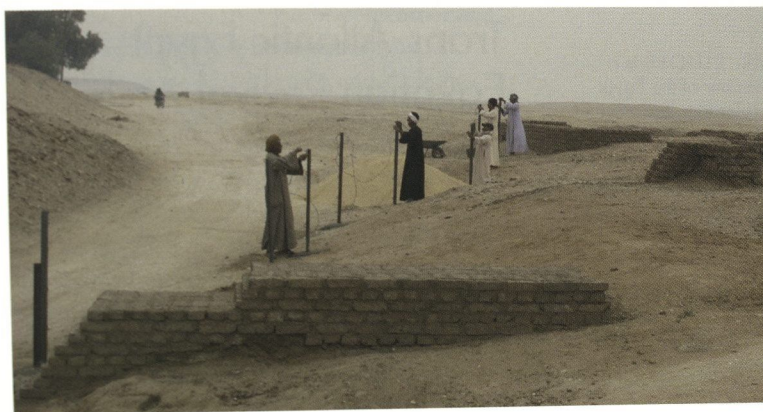
Fig. 10—Metal fencing being strung to prevent vehicles from driving through the Ho.W.1 structure on the west side of the modern road.

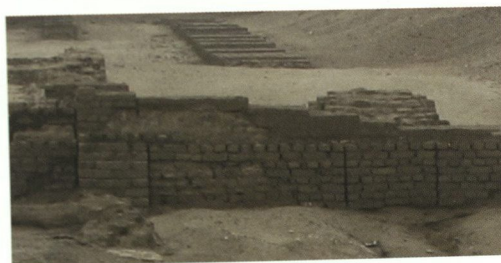
Fig. 11—Two areas where there was evidence of previous gaps in the northern wall of the entrance gate that had been filled up in ancient times.

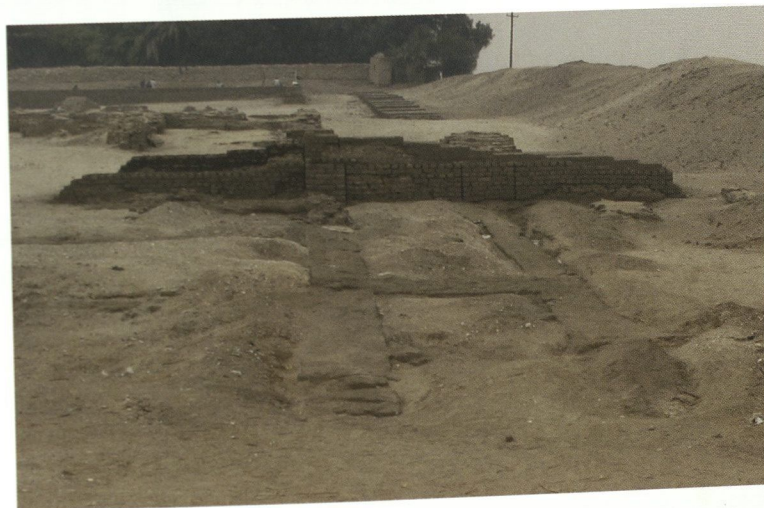
Fig. 12—Evidence of a ramp leading from the wadi to the northern side of the entrance gate to the King's Palace.
