THE PRODUCTION OF BRONZE AGE WALL
PAINTINGS IN THE EASTERN MEDITERRANEAN

# Malqata - The Painted Palace

# 2. Analysis of Painted Floor- and Wall Plasters from Malqata and Site K in Western Thebes

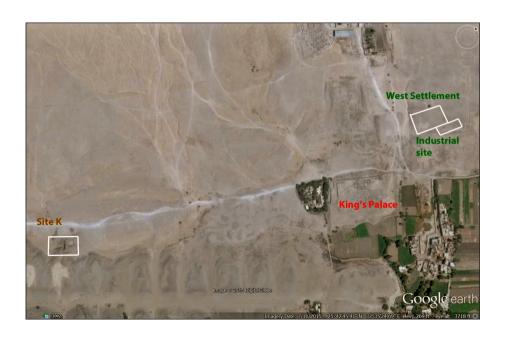
Fig. 2: Google Earth image of Malqata showing the location of Site K (by Joel Paulson; courtesy of the Metropolitan Museum of Art).

as Site K excavated by Kemp and O'Connor (Fig. 2).<sup>8</sup> And a number of painted plaster fragments with Aegeanising scenes were discovered there.<sup>9</sup>

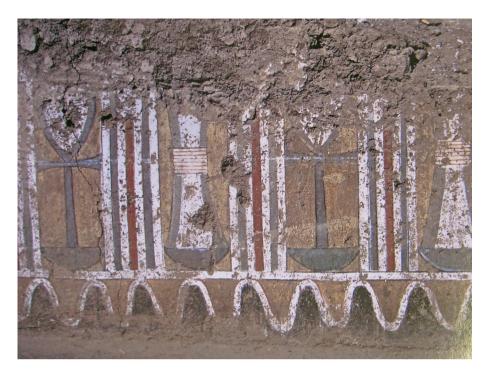
Fig. 4a: 'Wave Pattern' painted at the base of the interior west wall in the 'King's bedchamber' of the Palace of the King at Malqata (photograph by the author).

Room D appears to have had a wall painting of 'dancing girls' above a dado consisting of panels of 'false door' blocks set between alternating *sa* and *ankh* signs with an undulating line at its base. This motif is repeated throughout the palace. The pattern is a simplification of a very ancient type of decoration known in Egypt as 'palace façade'. This design in a much more elaborate form, is found decorating the mud brick tombs of the First and Second Dynasties. <sup>14</sup> It is an imitation of coloured woven matting that would have been used to embellish early structures of reed and wood. The undulating line represents the rope that would have secured the matting to 'curtain rods' running above and below the matting (Fig. 4).

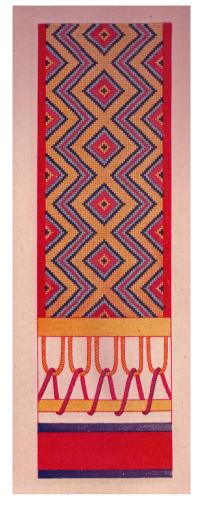
Fig. 4c: Origin of 'Wave Pattern' in a representation of rope tier for coloured mat panels at the base of a painted false door pattern from the Tomb of Hesy (Quibell 1913, pl. IX).

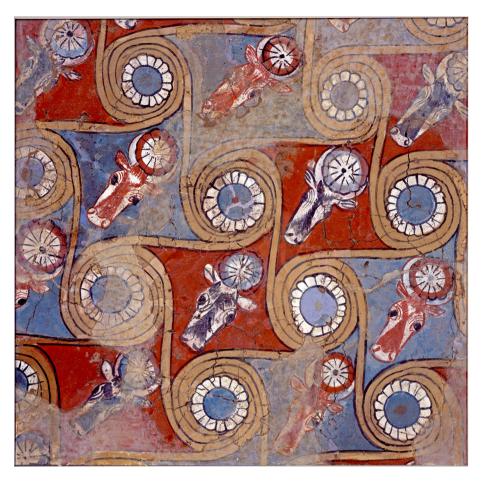
Fig. 5: Portion of ceiling painting from the Palace of the King at Malqata with repeating pattern of rosette-filled running spirals alternating with bucrania from the antechamber to the 'King's bedroom'; h. 140cm (55 1/8in), w. 140cm (55 1/8in) (Metropolitan Museum of Art Rogers Fund, (1911) MMA 11.215.451; photograph courtesy of the Metropolitan Museum of Art).

The 'antechamber' and the 'King's bedchamber,' however, were lavishly decorated. The ceiling of the 'antechamber' was decorated with an elaborate panel of running spirals, buchrania and rosettes (Fig. 5). The walls were covered with the panel decoration with undulating line base, that we have already seen in some of the other rooms of the palace. The 'King's bedchamber' had a ceiling decorated with flying vultures and the panel dado as in the antechamber. In this room it was surmounted by paired figures of the god *Bes.*<sup>19</sup>

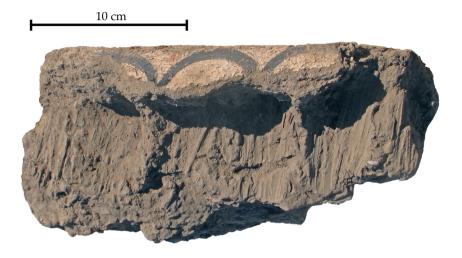
Fig. 6a: Fragment of a cavetto cornice modelled in mud and painted from the Palace of the King at Malqata (photograph by the author).

had shelves with cavetto cornices modelled in mud plaster.<sup>21</sup> Fragments of other sculptural elements in mud plaster, wood and faience used as architectural decoration were found throughout the palace (Fig. 6).

Some of these were architectural elements such as torus moldings modelled in mud and then painted or even a cavetto cornice set into the wall on wooden sticks driven in at an oblique angle and then the cornice modelled in mud and painted (Fig. 6). Other, purely decorative painting included elements of ceiling patterns, floral swags and even figural decoration. While much of the ceiling and floor paintings survived intact, preserved when the roof of the palace 'pancaked in', far less of the wall decoration remained so it is still unclear what the extent and composition of these decorations were like. Both the surviving architectural embellishments and the mural decoration in the Palace of Amenhotep III are, by far, the most completely preserved of any Egyptian royal palace and suggest aspects of both the symbolic and actual function of the royal residence.

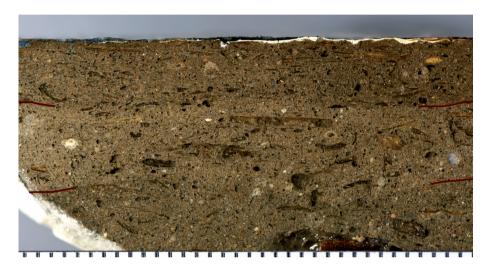
Fig. 9: Ceiling fragment with three layers of dark brown Nile clay plaster (red lines mark the borders). The composition of the plasters varies slightly in the content of mineral aggregates and organic fillers made from finely chopped and coarser plant fibres. The upper plaster carries a polychrome ceiling painting. Scale 1mm.

Often multi-layered plaster stratigraphies can be observed, as especially ceilings but also selected wall levels have been built with up to three plaster layers in one building phase (Fig. 9). The plant fibre content is mostly higher and coarser in the lower plaster layers. These contain also bigger plant fragments as rounded stem pieces, partly from the matting used as reinforcement of the ceilings into which the lowest plaster layer was pressed.
